What's Next Analysis of the US Magnesium Superfund Site
TAG (Technical Advisory Group)

William P. Johnson
TAG Advisor to FRIENDS of Great Salt Lake
09-18-2025

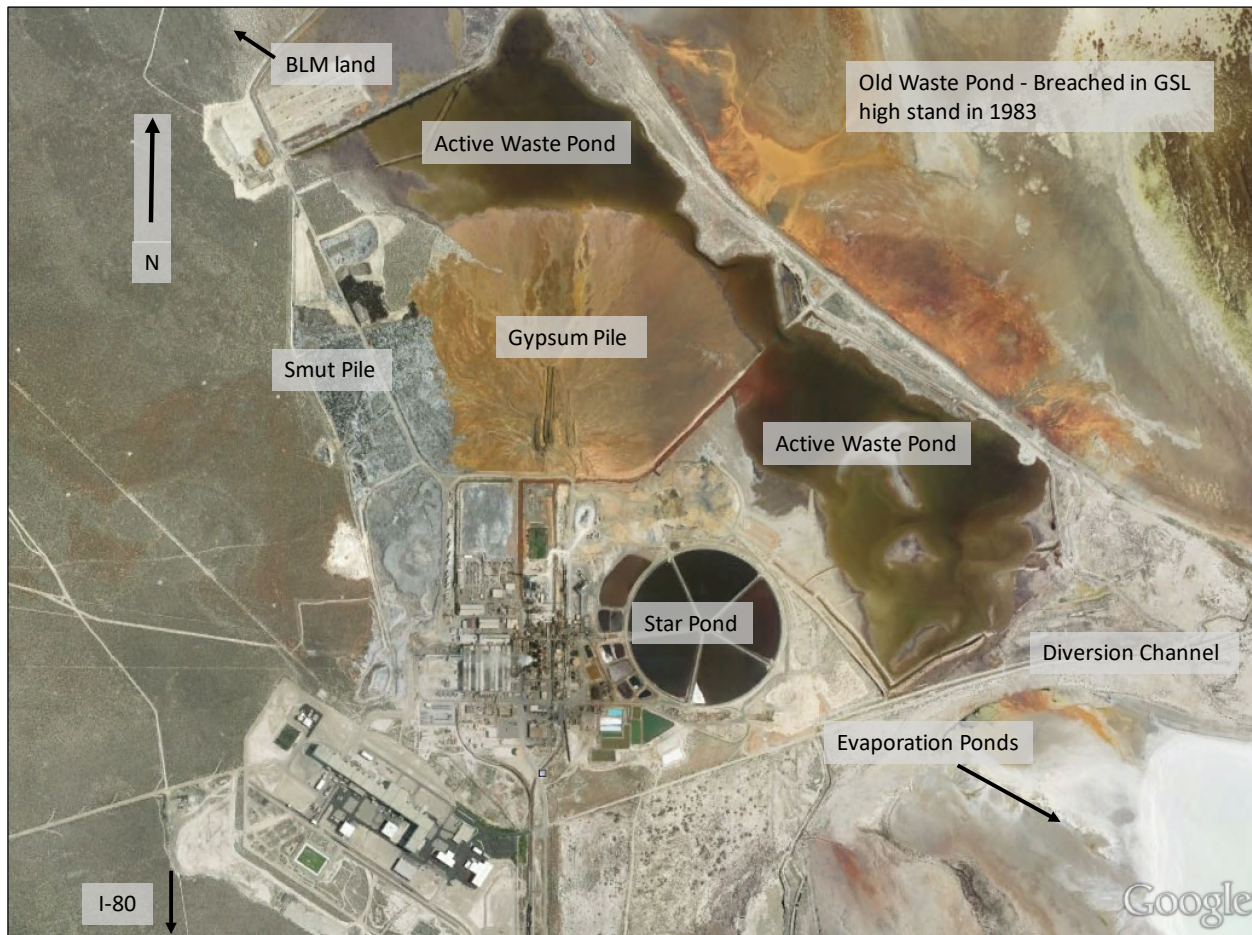
Figure 1. US Magnesium site layout showing Star Pond, Active Waste Pond, Gypsum Pile, Smut Pile, and Old Waste Pond.

Since RCRA concerns stewardship of newly generated wastes, it governed the areas of the site closest to the operating plant, i.e., west and south of and including the Active Waste Pond (Figure 1). CERCLA, also known as "Superfund" governs previously spilled wastes, and so governed the site outward from the Active Waste Pond, including the Old Waste Pond (Figure 1). Whereas the Active Waste Pond is no longer receiving plant discharge, the name is retained here in order to remain consistent with terms used in previous documents.

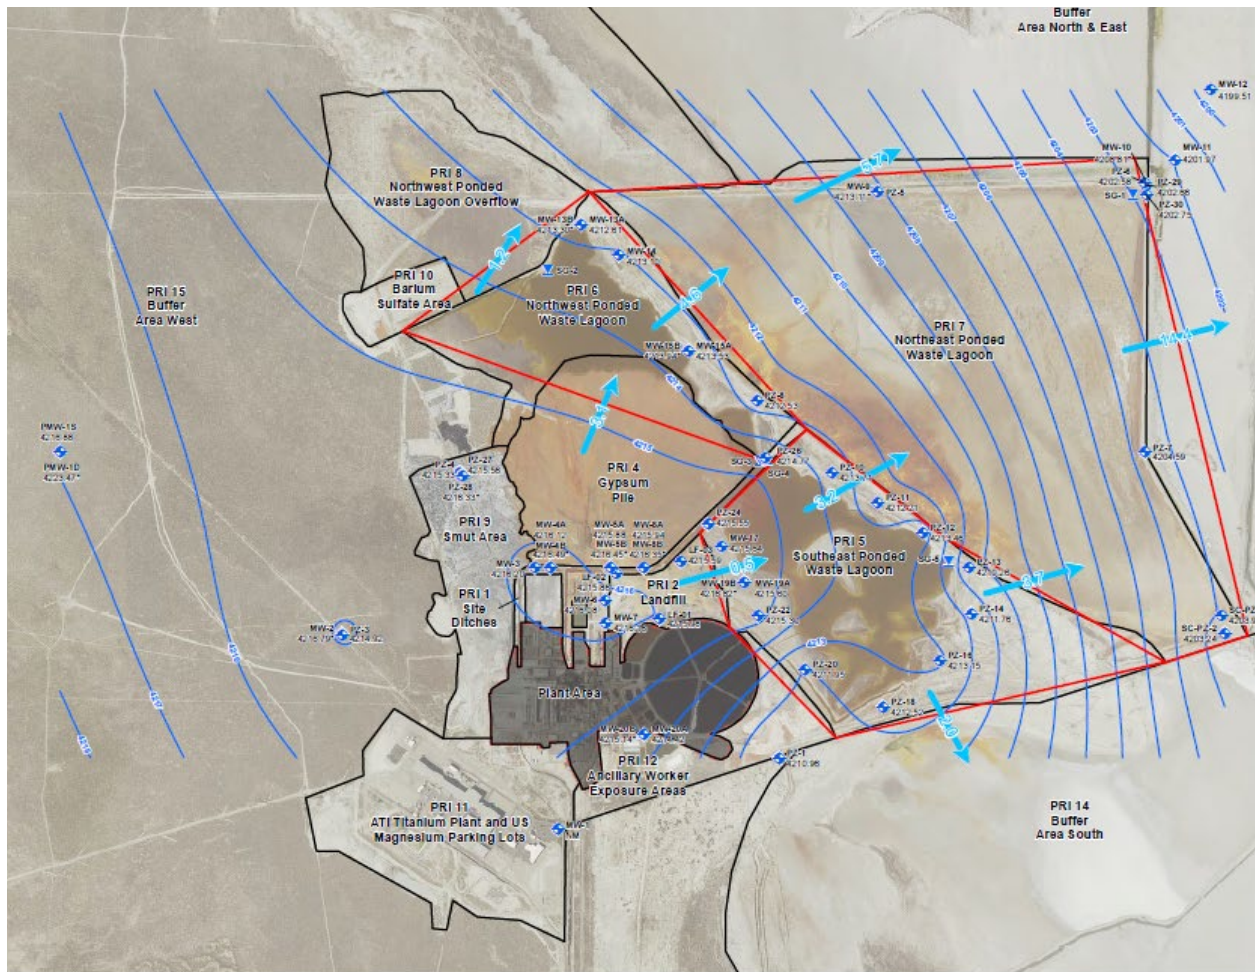
Figure 2. Groundwater hydraulic head contours (blue lines) determined from hydraulic head measurements in wells. Wells are indicated by blue circular symbols. Blue arrows denote general ground water westward toward Great Salt Lake.

During operation, the site hydrology showed that groundwater was mounded under the site due to loading from waste discharge ([Figure 2](#)) ([Phase 2B Hydro Remedial Investigation Data Report, May 2020, Groundwater Discharge Permit Application by US Magnesium Corporation, 2018](#)). Groundwater mounding is indicated by the close blue circle under the CERCLA portion of the site southwest of the Gypsum Pile ([Figure 2](#)) which denotes a local high in the groundwater hydraulic head, from which groundwater would flow in all directions, but particularly eastward toward Great Salt Lake, as indicated by the larger blue arrows. This predominant flow is perpendicular to the contours (blue lines) that connect equal hydraulic head, as measured in wells. The fact that the hydraulic head contours are spaced closer together east of the Active Waste Pond ([Figure 2](#)) shows that a steeper hydraulic gradient exists east of the Active Waste Pond, and this can be expected to drive increased groundwater flow to the east toward Great Salt Lake.

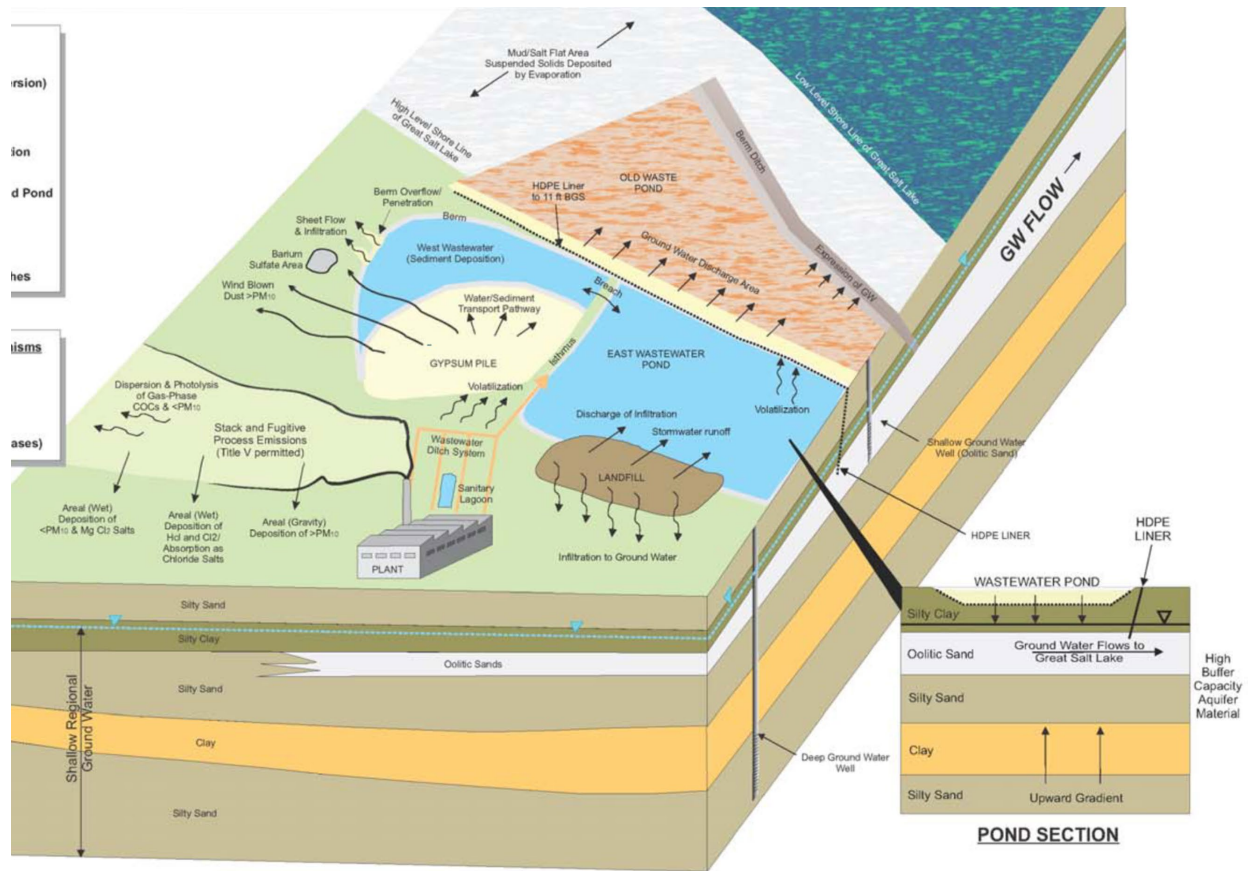
Figure 3. Box diagram of sedimentary layers (strata) beneath the US Magnesium site.

Equally concerning to the eastward groundwater flow is the fact that the flow is not expected to be uniform, but rather, higher and faster flow is expected in subsurface layers (strata) that are more permeable, with oolitic sands being a highly permeable layer (Figure 3) (Final Old Waste Pond Conceptual Site Model (OWB_CSM) Hydrologic Report, 2017). In addition to the oolitic sand layer, the fact that the acidic waste also dissolved channels into the underlying sediment (Figure 4) produces additional pathways for potential conveyance of contaminants outward from the site.

Since both a hazardous source (the US Magnesium site) and a likely pathway to Great Salt Lake exist, the need to determine the flux of contaminants outward (predominantly eastward) from the RCRA and CERCLA sites is urgent. This need is made more urgent by the fact that the planned barrier wall was designed to increase the waste pond footprint by a factor of three, which demonstrates that the waste balance performed by US Magnesium's consultants determined that two thirds of the discharged waste was leaving the site via unknown subsurface routes ([Final Old Waste Pond Conceptual Site Model \(OWB_CSM\) Hydrologic Report, 2017](#); [Groundwater Discharge Permit Application by US Magnesium Corporation, 2018](#); [Retrofitted Waste Pond Phase 1 Basis of Design Report - US Magnesium Facility, Revision B, 2019](#)). Finally, the fact that the barrier wall was implemented as a surface berm, never having been completed with a clay core notched into the underlying clay ([Figure 3](#)) as originally planned, and the fact that several

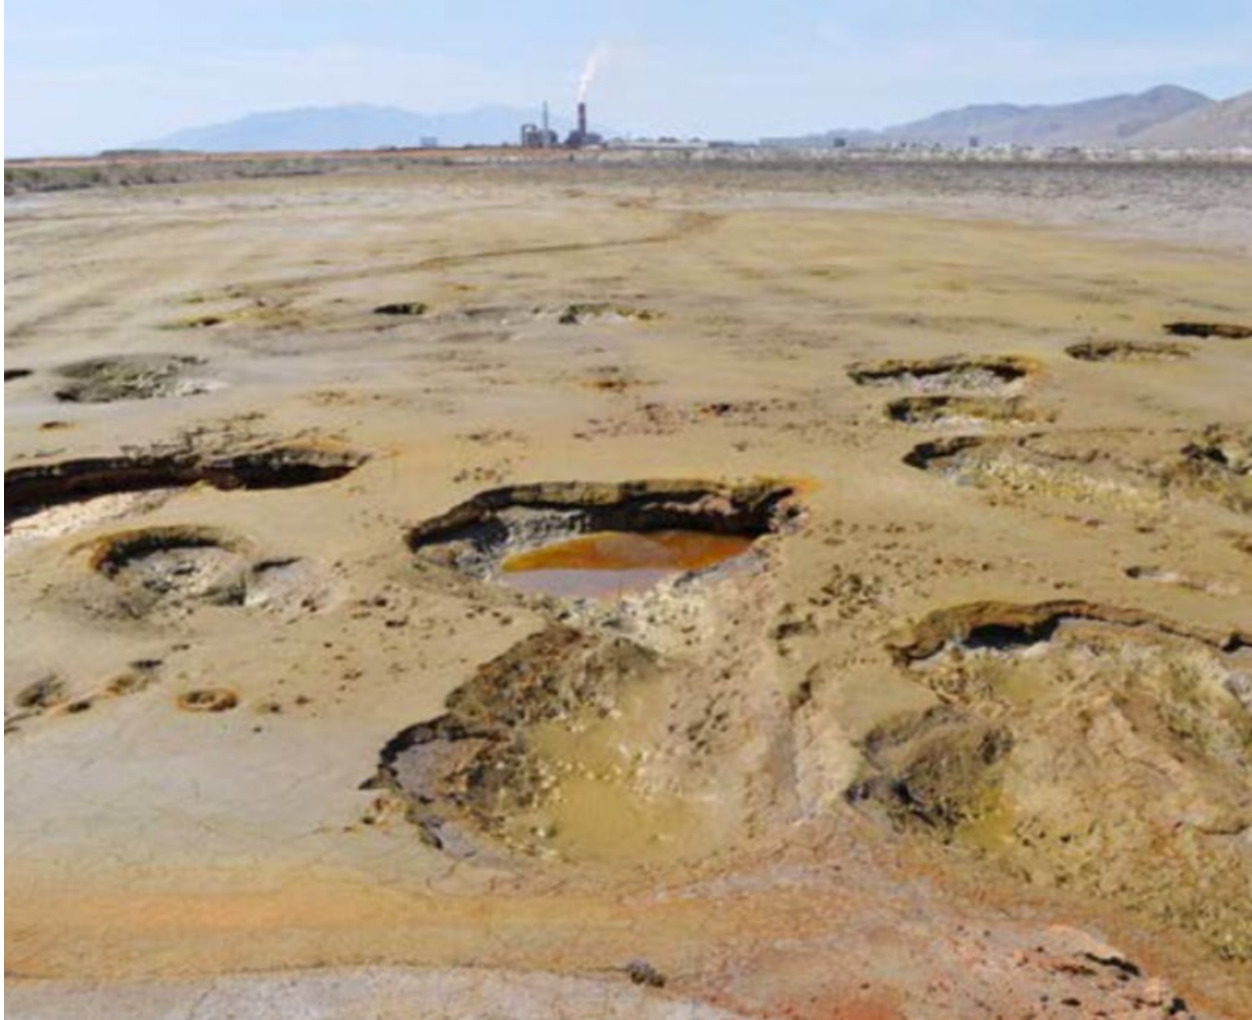
Figure 4. Image of dissolution channels observed as surface sinkholes in the bed of the active waste pond. US Magnesium plant is seen in the middle distance (looking south).
